ASPEN Environmental Consultants, Inc; Report of Tests: Preliminary Evaluation of Three Erosion Control Products

Preliminary Evaluation of Three Erosion Control Products

Utah Water Research Laboratory
Utah State University
Logan, UT 84322-8200

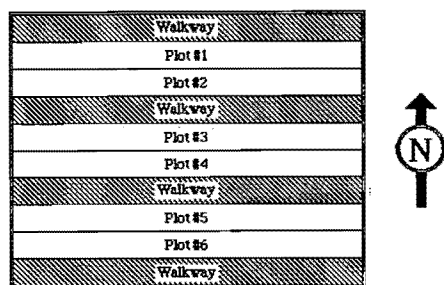
Figure 1. Plot configuration.

Figure 1 shows the plot configuration for all three tests. Water and sediment runoff data are presented in Table 1 for all three tests. Table 2 contains plant data collected from the first test. Figures 2 through 6 are graphical representations of data presented in the tables.

which is covered with a filter cloth through which water can drain. For the Aspen Environmental Consultants tests, the flume was divided into six test plots, each measuring 2 feet by 19.5 feet. There were three sets of two plots each, and the sets were separated from each other and from the side walls by 2-foot wide walkways. The rainfall simulator was arranged so that rain fell upon the plots and not upon the walkways. Runoff from each test plot was collected in a plastic container and weighed. The water was decanted off, and the soil was dried and weighed to determine the amounts of soil and water leaving each plot per unit of time.

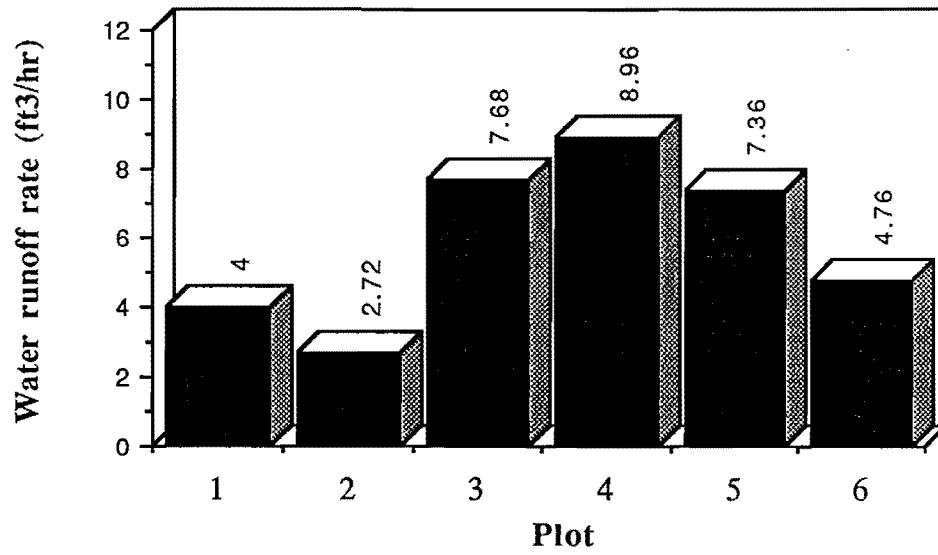
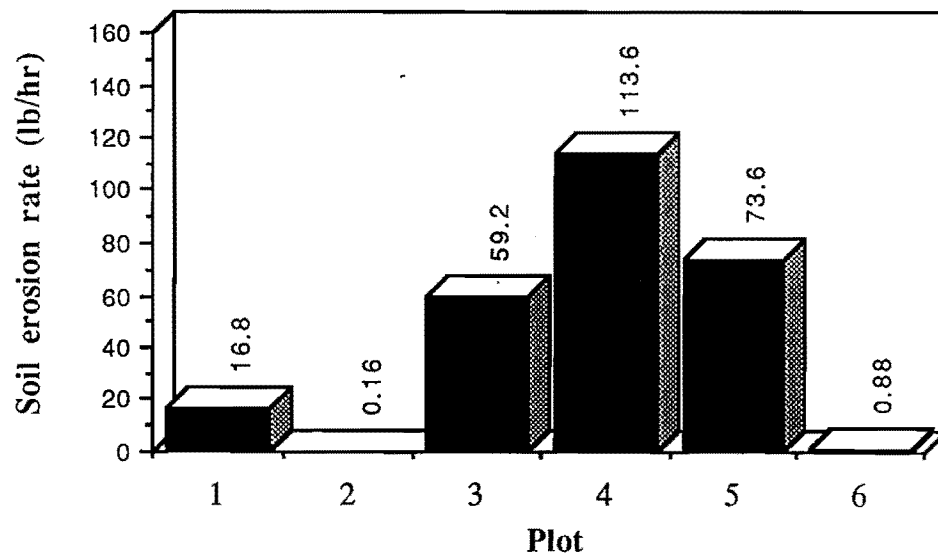
Figure 2. Water runoff and soil erosion rates for the six plots of Test 1.

Water runoff rate. The water runoff rates for the six plots of Test 1 are presented in Table 1 and Figure 2. As shown in the tables, the Coconut fiber channel liner (plot #2) had the best retention capacity as the water runoff rate was the smallest of all products tested. The 300 gal/Ac Entac emulsion at 4:1 dilution on plot #1 and the Proseed PS100 mulch blanket on plot #6 had the next best performances. The performance of the 200 gal/Ac Entac emulsion at 7:1 dilution (plot #3) was similar to the two control plots, plots 4 and 5.

Soil erosion rate. Soil erosion rates for Tests 1, 2, and 3 are presented in Figures 2, 3, and 4, respectively. They are also listed in Table 1. In Test 1, in terms of erosion protection, the Coconut fiber channel liner (plot #2), and the Proseed PS100 mulch blanket (plot #6) performed better than the two Entac emulsion applications (plots #1 and #3). Their erosion rates were two orders of magnitude smaller than those of the Entac emulsion plots. The Coconut liner and the PS100 mulch blanket performed even better when compared with the bare soil control plots (plots #4 and #5). Their erosion rates were between two and three orders of magnitude smaller than those of the control plots. From the two Entac emulsion applications, plot #1, 300 gal/Ac at 4:1 dilution, performed better than plot #3, 200 gal/Ac at 7:1 dilution. Both applications reduced the erosion rate in comparison with the control plots.

In Test 2 wherein the same products were used as in Test 1, the values of the erosion rate were similar to, although in general smaller than, those of Test 1. This conclusion is easily reached by comparing the lower parts of Figures 2 and 3. These results indicate that the higher water content of the soil in Test 2 had very little effect on the erosion rates of Test 2 over those of Test 1.

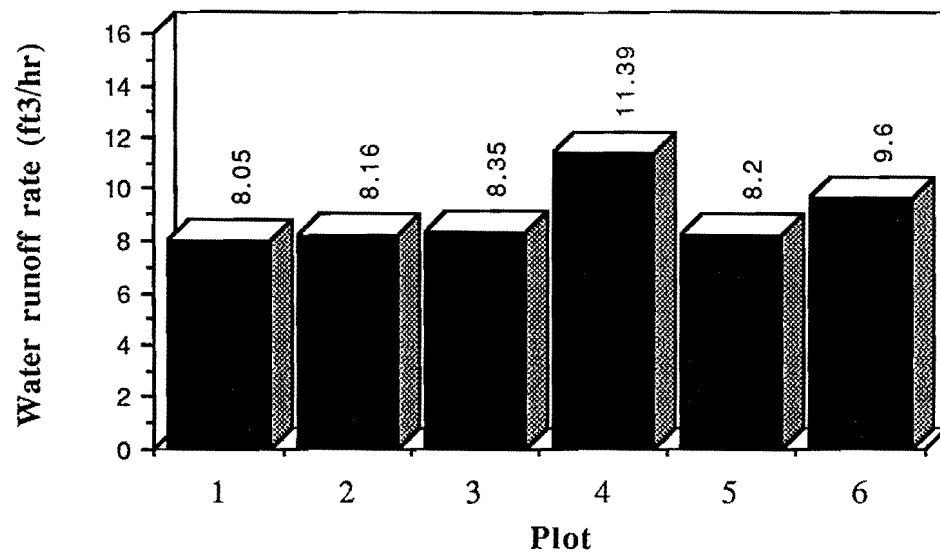
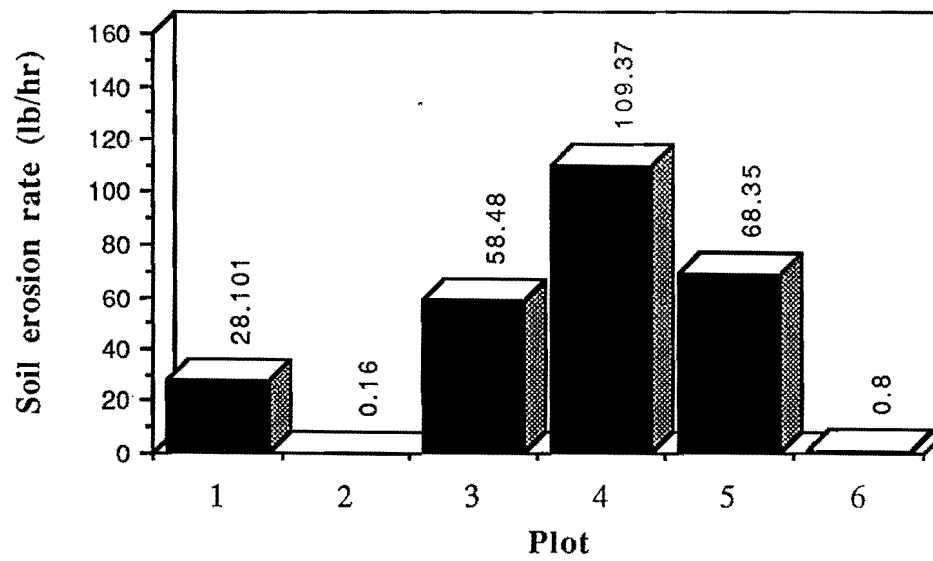
Figure 3. Water runoff and soil erosion rates for the six plots of Test 2.

The water runoff rates for Test 2, presented in Figure 3 and in Table 1, indicate very little difference between the plots. This is because the soil at the start of the rain had a high moisture content

which remained from the first run; therefore, most of the water from the second test ran off.

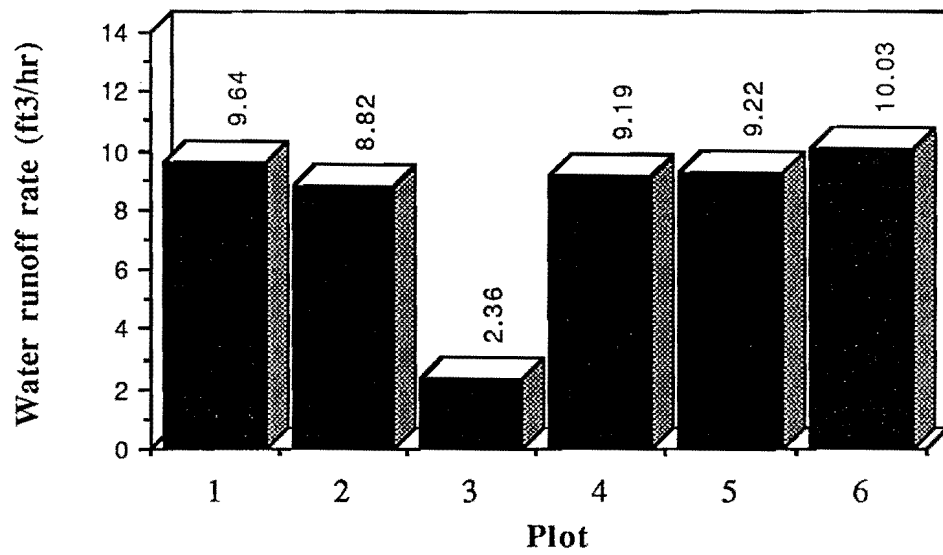
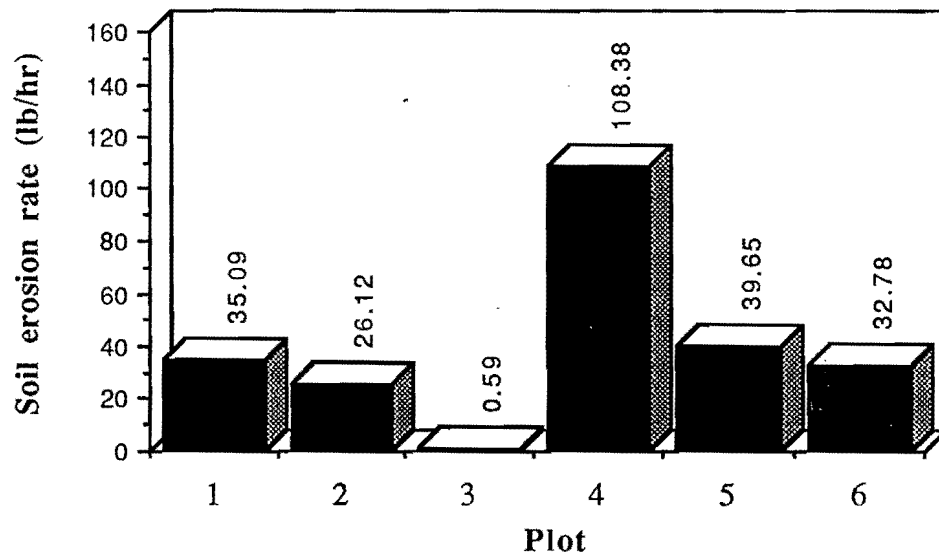
Figure 4. Water runoff and soil erosion rates for the six plots of Test 3.

For Test 3 the soil was drier than at the start of Test 2 but not as dry as at the beginning of Test 1. The water runoff rates for this test are shown in Figure 4 and Table 1. The best performance in water retention occurred for plot #3 which was covered with straw and a straight Entac emulsion. This combination was able to absorb and retain a good percentage of the total water applied so that very little runoff occurred as compared to the other plots. All other applications performed equally among themselves retaining water in comparable amounts to that of the control plot (plot #4). The runoff rates for all plots, excluding plot 3, are similar to those obtained in Test 2, indicating a considerable amount of moisture in the soil at the beginning of the test.

The results of erosion control for Test 3 indicate that the combination of straw with a straight Entac emulsion (plot #3) gave the best performance in terms of erosion protection. The erosion rate of plot #3 was two orders of magnitude smaller than were the rates of the other Entac emulsion applications (plots #1, 2, 5, and 6), and three orders of magnitude smaller than the bare soil control plot. Erosion rates for the four different Entac emulsion applications were very similar in magnitude. However the best rate resulted in plot #2, which had 300 gal/Ac Entac emulsion at 4:1 dilution followed by a second application of 300 gal/Ac Entac emulsion at 2:1 dilution. The erosion rates for all the Entac emulsion applications

were in the order of three times smaller than the erosion rate of the control plot.

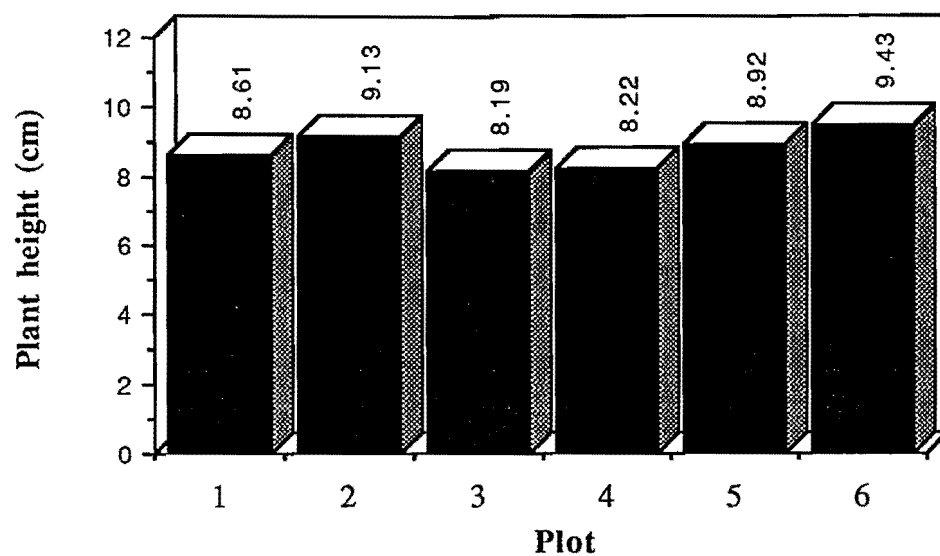
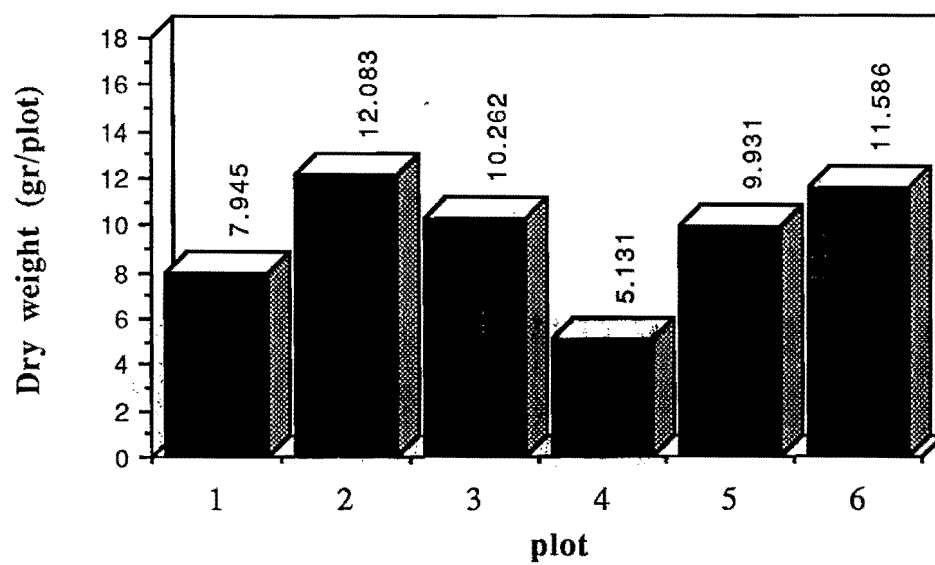
Figure 5. Plant height and dry weight data for the six plots of Test 1.

Plant data. Plant data were collected only for Test 1; these results are presented in Table 2. The top part of Figure 5 shows the average plant heights for all six plots. It is evident that no significant difference in plant heights existed among the different plots. This indicated that none of the erosion control methods tested had an effect on plant height. However, this test served to demonstrate that plants can grow through the Coconut fiber channel liner and through the Proseed PS100 mulch blanket.

The bottom part of Figure 5 indicates some effect of the erosion control treatments on the dry weight of plants per plot. Both the Coconut fiber channel liner (plot #2) and the Proseed PS100 mulch blanket (plot #6) produced a higher dry weight of plants per plot than did the control plots (plots #4 and #5) or the two Entac emulsion applications (plots #1 and #3). The relatively high yield in dry weight per plot of plots #2 and #6 can be attributed to the fact that they contained the highest percentage of germinating seeds, as indicated in Figure 6. The dry weight per plot for plots #1 and #3, both with Entac emulsions, were higher than control plot #4 but comparable to that of control plot #5. Again, the higher percentage of germinating seed seem to be the cause of the greater dry weight per plot. The evidence is inconclusive regarding beneficial effects of the Entac emulsion on dry weight of plants per plot.

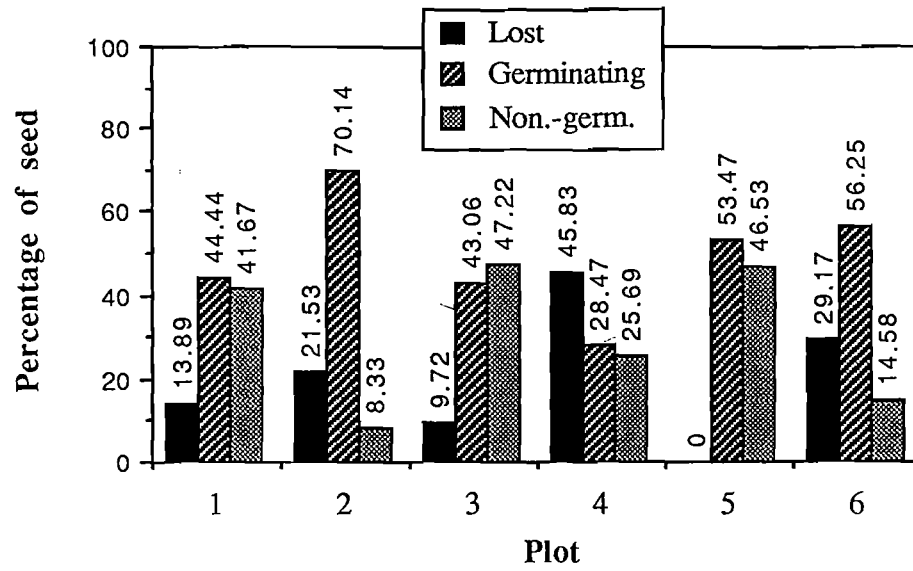
Figure 6. Percentage of seed lost, germinating and non-germinating for the six plots of Test 1.

In terms of percentages of seed lost, germinating and non-germinating, the results are presented graphically in Figure 6. The best performance in germinating seed was that of the Coconut fiber channel liner (plot #2), followed by that of the Proseed PS100 mulch blanket (plot #6). However, the latter was only slightly better than con-

trol plot #5. Strangely enough, control plot #4 lost only about half as many seeds as did control plot #5. For the two Entac emulsion plots (plots #1 and #3), the percentage of germinating seed is similar in magnitude, smaller than the other two treatments, and in between the results of the two control plots.

The large discrepancy in seed percentage data between control plots #4 and #5 may lead to unrealistic results. Control plot #5 indicates no seeds lost, which we know is not so. This result came about because the total number of plants and non-germinating seeds from the three samples taken in that plot was equal to the estimated number of seeds applied. The sample areas had an over-supply of seeds resulting in the unrealistic high count. Therefore, the data of control plot #5 in terms of seed percentages should be disregarded, and all other data compared to those of plot #4 only. If that is the case, then the performances of the Coconut liner, the mulch blanket, and the two Entac emulsion applications are definitely better than the performance of control plot #5 in terms of the percentage of seed retained and germinating.
